Spring Hill Natural Area

Gaining Traction: Water Quality, Habitat & Public Health

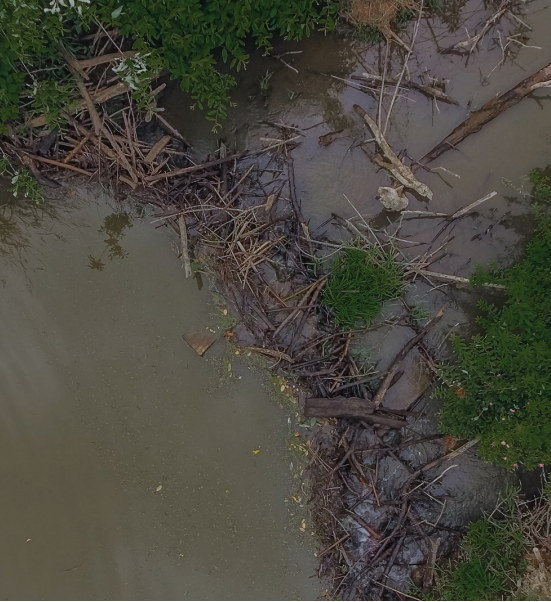
↓
Crews created more natural flow paths for two seasonal creeks and placed large wood to improve stream and wetland functions.

channels; and installing native sedge/ rush mats and large woody debris in those channels to slow and clean the water while creating habitat. Revegetation of the newly constructed channels began with the application of hydroseed mix embedded with native grass and wildflower seed, followed soon by installation of thousands of bare-root native shrubs.

Now, for the first time in decades, two creeks at Spring Hill travel aboveground, following slow and curving channels on their way to the Tualatin River. As the river swells, it meets a reconnected floodplain free of impediments. Conditions are in place for the return of the rare prairie

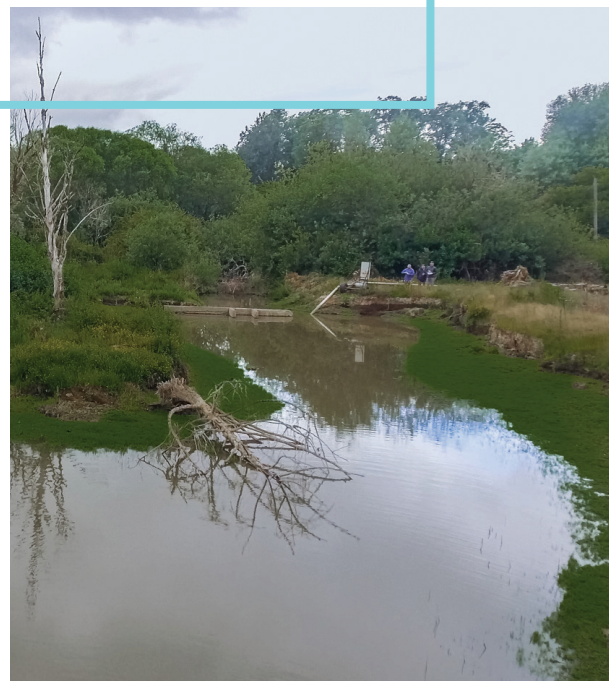
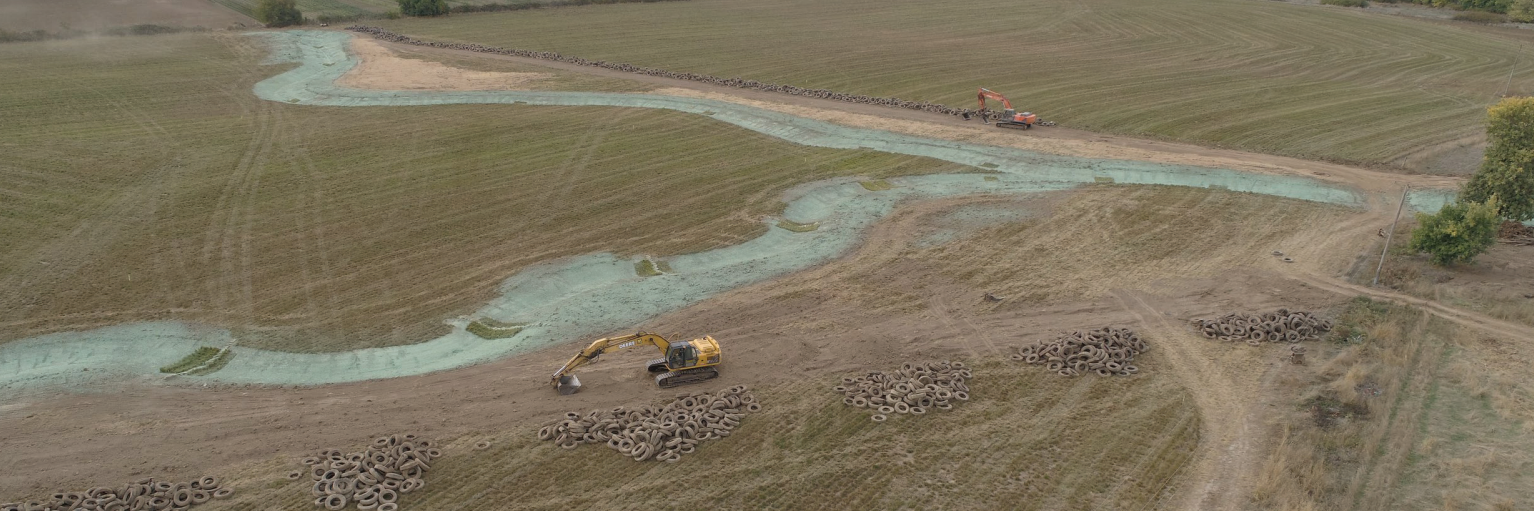
Five creeks touch the site, as does the main stem of the Tualatin.

Five creeks (Harris, Fern Hill, Wapato, Scoggins, and an unnamed tributary) touch the site, as does the main stem of the Tualatin. For decades, much of the creek water within Spring Hill's northern parcel disappeared underground into a drainage system that made agricultural activities more efficient. In the summer of 2018, after removing a small dam, contaminated soil that disconnected wetlands, and roughly 4,000 semi-truck tires that had served as the makeshift drainage system, crews created more natural flow paths for two seasonal creeks and placed large wood to improve stream and wetland functions. Cattle grazing continues at the site, as does farming of tall fescue, clover and wheat. Today, Spring Hill Natural Area functions as both productive working land and a showcase of ecological enhancement strategies.
